**Appendix K**  
*Impact Assessment of the N/S-W  
and E-N/S Ramp Realignments*

<b>Subject</b>	<b>Impact Assessment of the N/S-W and E-N/S Ramp Realignments (Final - Rev A)</b>	<b>Project Name</b>	Hawkesbury Bridge Replacements
<b>Attention</b>	Brian Utigard (MTO)	<b>Project No.</b>	GWP 4203-15-00
<b>From</b>	Junaid Ahmed (Jacobs)		
<b>Date</b>	September 1, 2020		
<b>Copies to</b>	Frank Vanderlaan (MTO) Matthew McFadden (Jacobs) Douglas Raby (Jacobs) Vlad Manalastas (Jacobs) Tanya Cross (Dillon) Brendan Peterson (Dillon) Adele Mochrie (Dillon) Catherine Rebry (Dillon)

TO: Brian Utigard, P.Eng, Ministry of Transportation, Ontario (MTO)  
FROM: Connor Edington, Dillon Consulting Limited (Dillon)  
cc: John Hanna, MTO  
Frank Vanderlaan, MTO  
Matthew McFadden, Jacobs  
Adele Mochrie, B.Sc., Dillon  
Dayna LeClair, Dillon  
Tanya Cross, P.Eng., Dillon  
Brendan Peterson, Dillon  
DATE: July 14, 2020  
SUBJECT: County Road 17 Bridge Replacements (GWP 4023-15-00)  
Natural Heritage Existing Conditions Update Memo  
OUR FILE: 17-5180

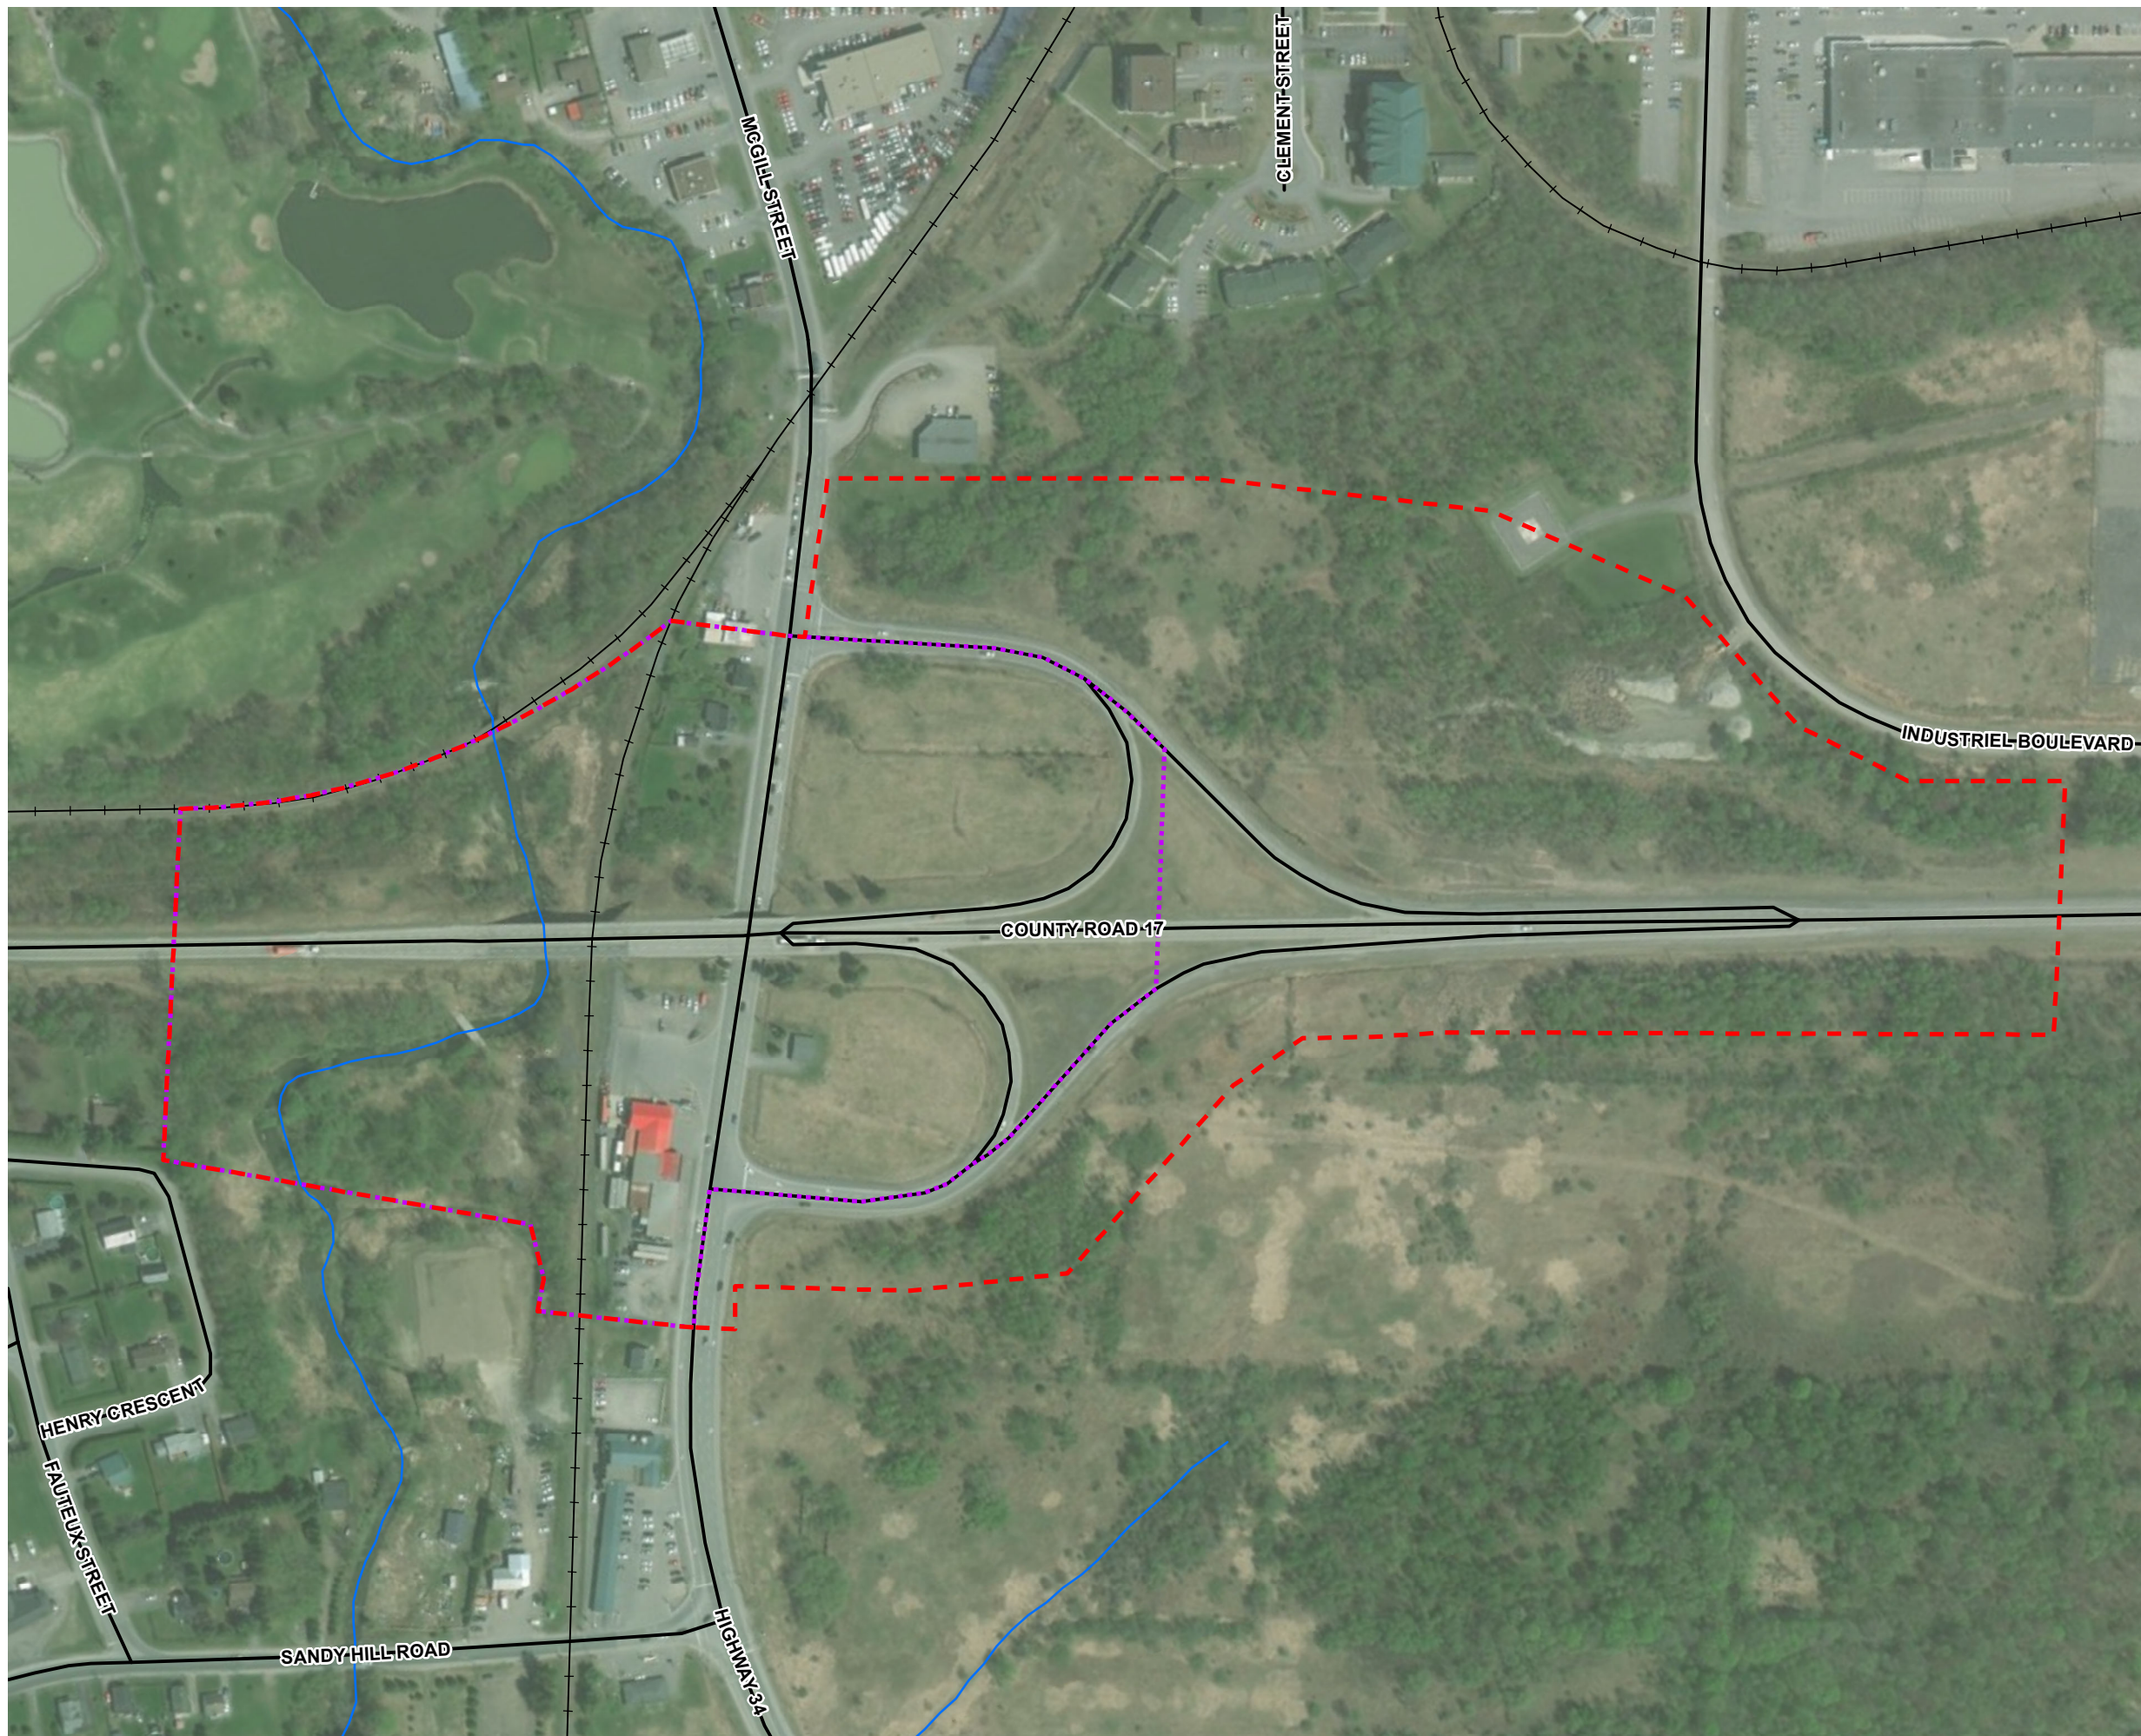
FIGURE 1

This project is being completed under the Retainer and includes the replacement of two structures on County Road 17 in the Town of Hawkesbury, namely, Hawkesbury Creek/CNR Overhead (Site No. 27-50) and Highway 34 Underpass at County Road 17 (Site No. 27-51) (Attachment 1, Figure 1) under GWP 4023-15-00.

N/S ramp will also need to be realigned. The shift of the E-N/S and N/S-E ramps further east results in additional impacts beyond the original Study Area. Based on the revised areas of impact, an extension of the original Study Area has been proposed to encompass additional lands east forming a revised area of investigation (Revised Study Area) as shown in (Attachment 1, Figure 1).

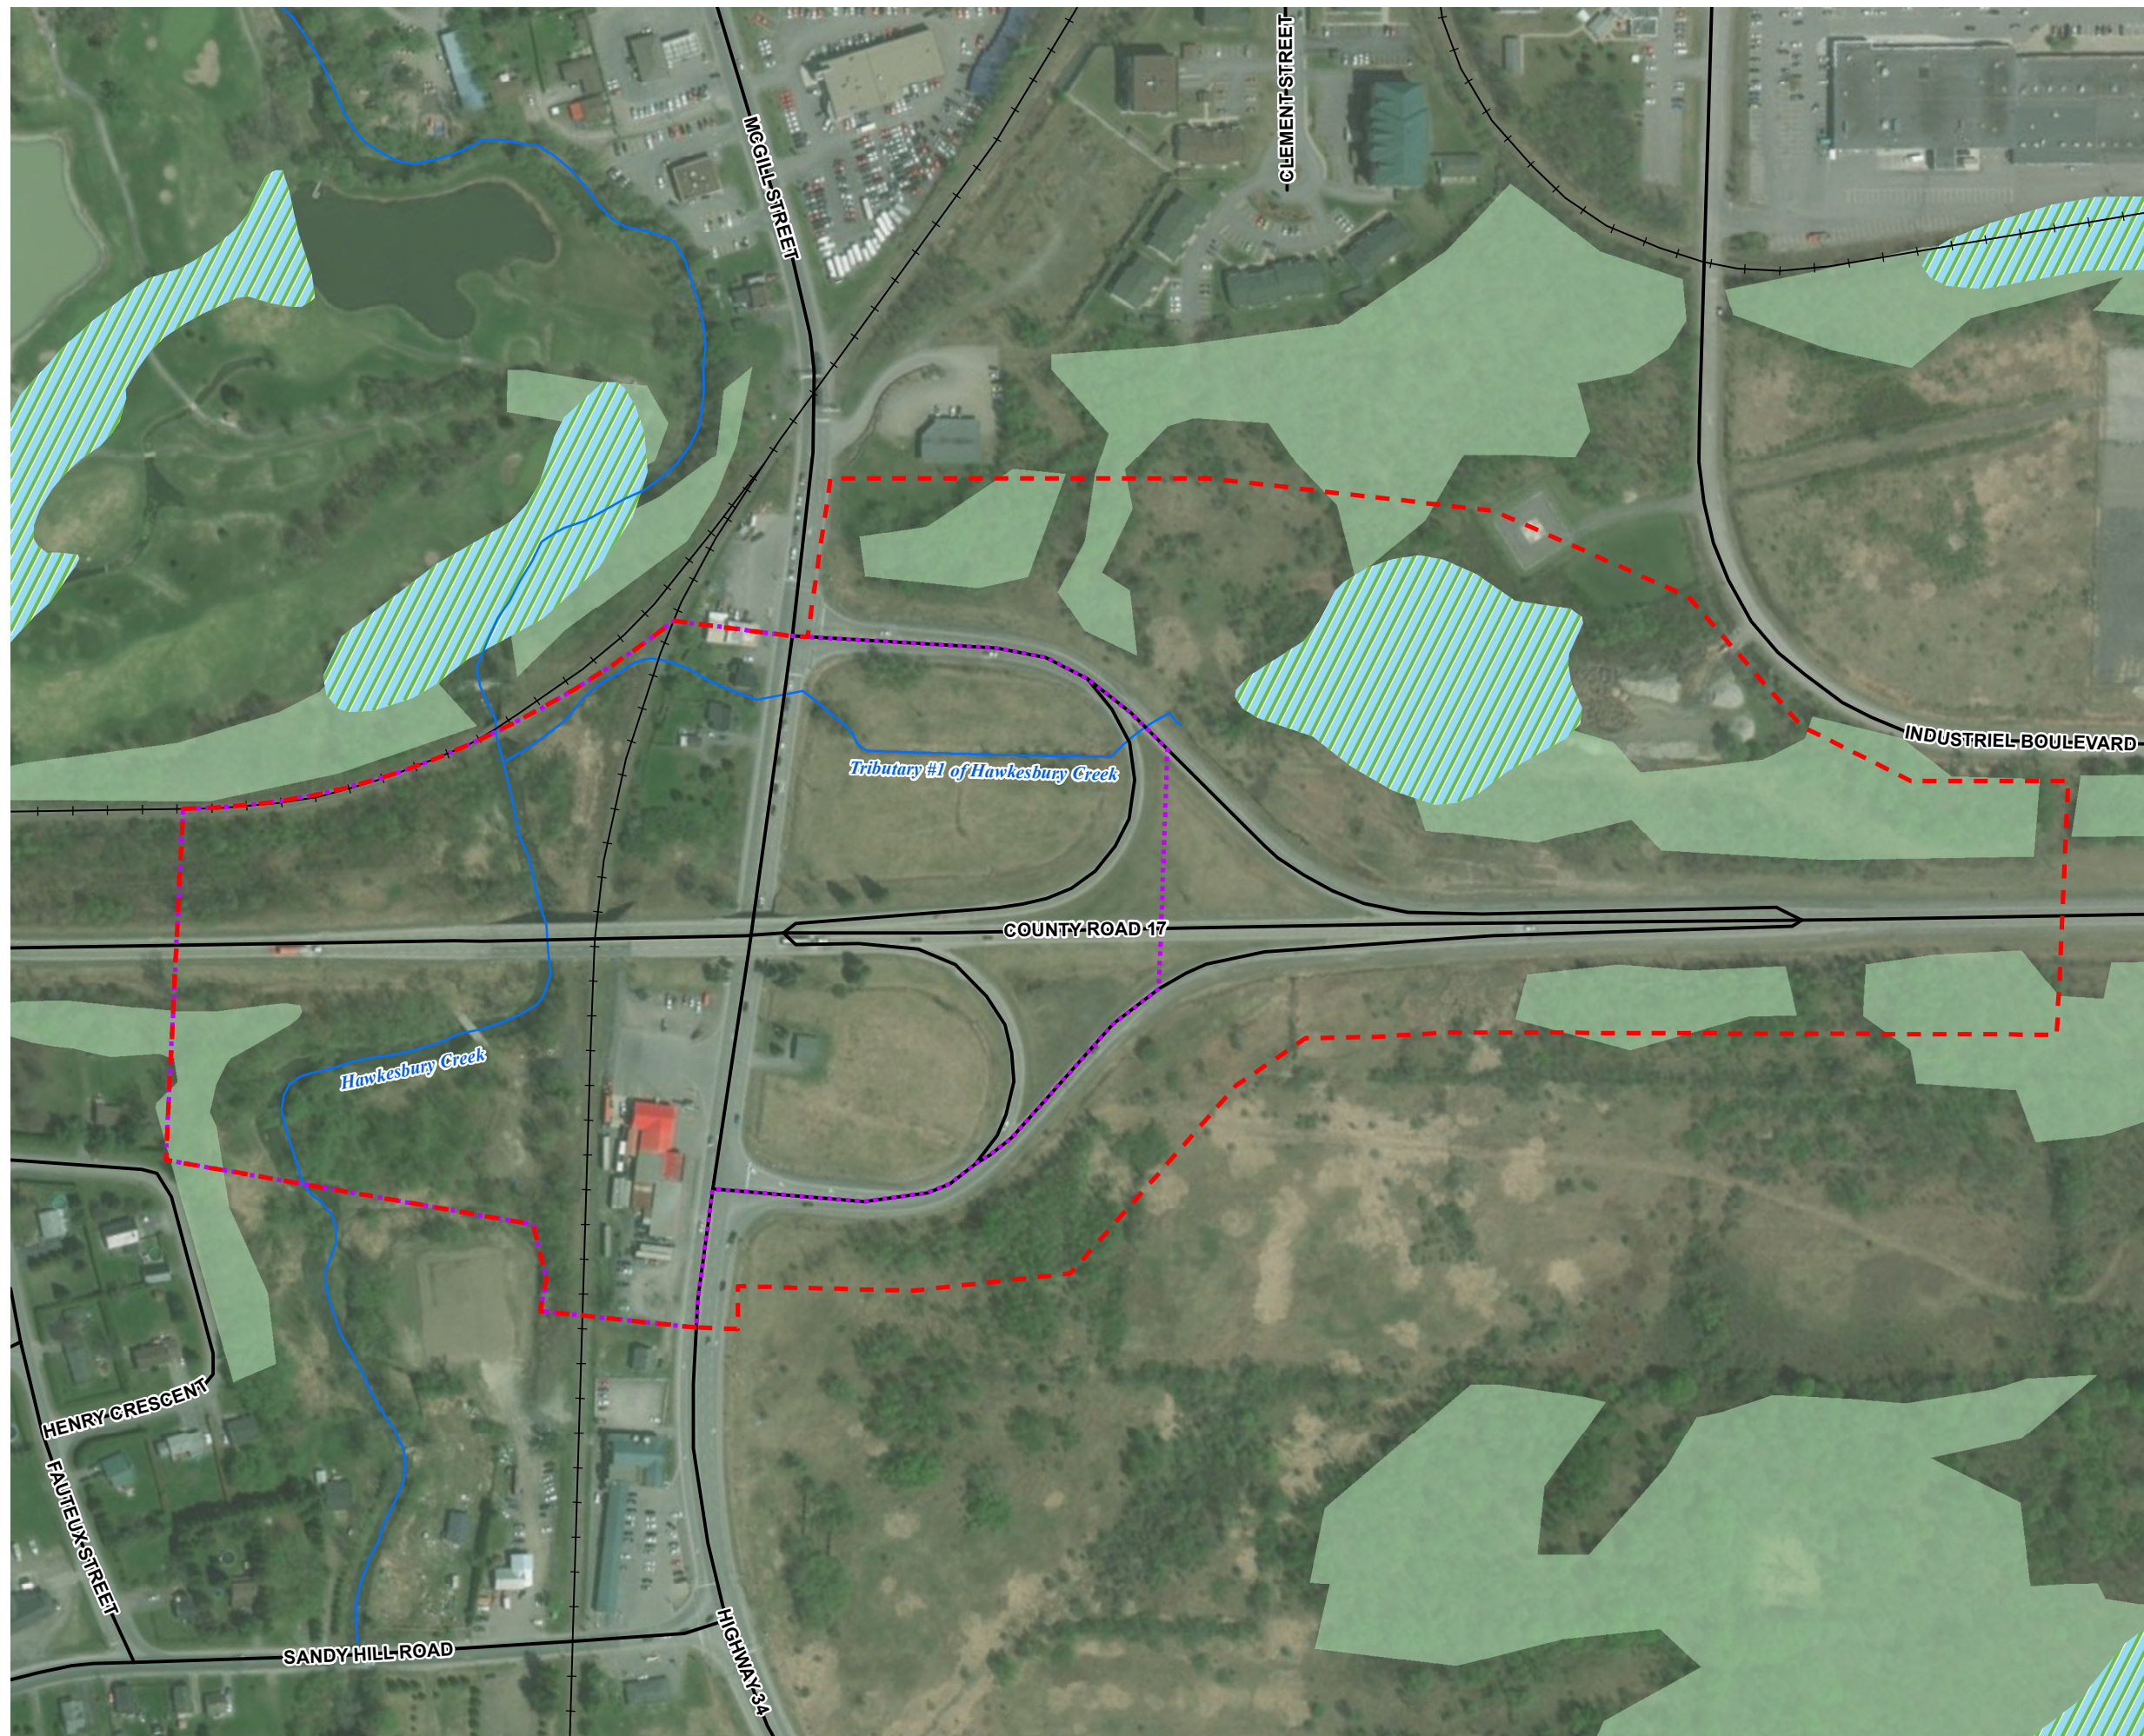
FIGURE 2

Provincially Significant Wetlands (PSWs) are identified by the MNRF, where they have been evaluated. The MNRF LIO database was reviewed to identify wetland occurrences within the Revised Study Area, and when possible, visual interpretation during the field investigation. Based on the background review, unevaluated wetlands occur within the Revised Study Area, however no PSWs occur within or adjacent to the Revised Study Area. Unevaluated wetlands identified by the MNRF LIO database are shown on Figure 2 in Attachment 1.

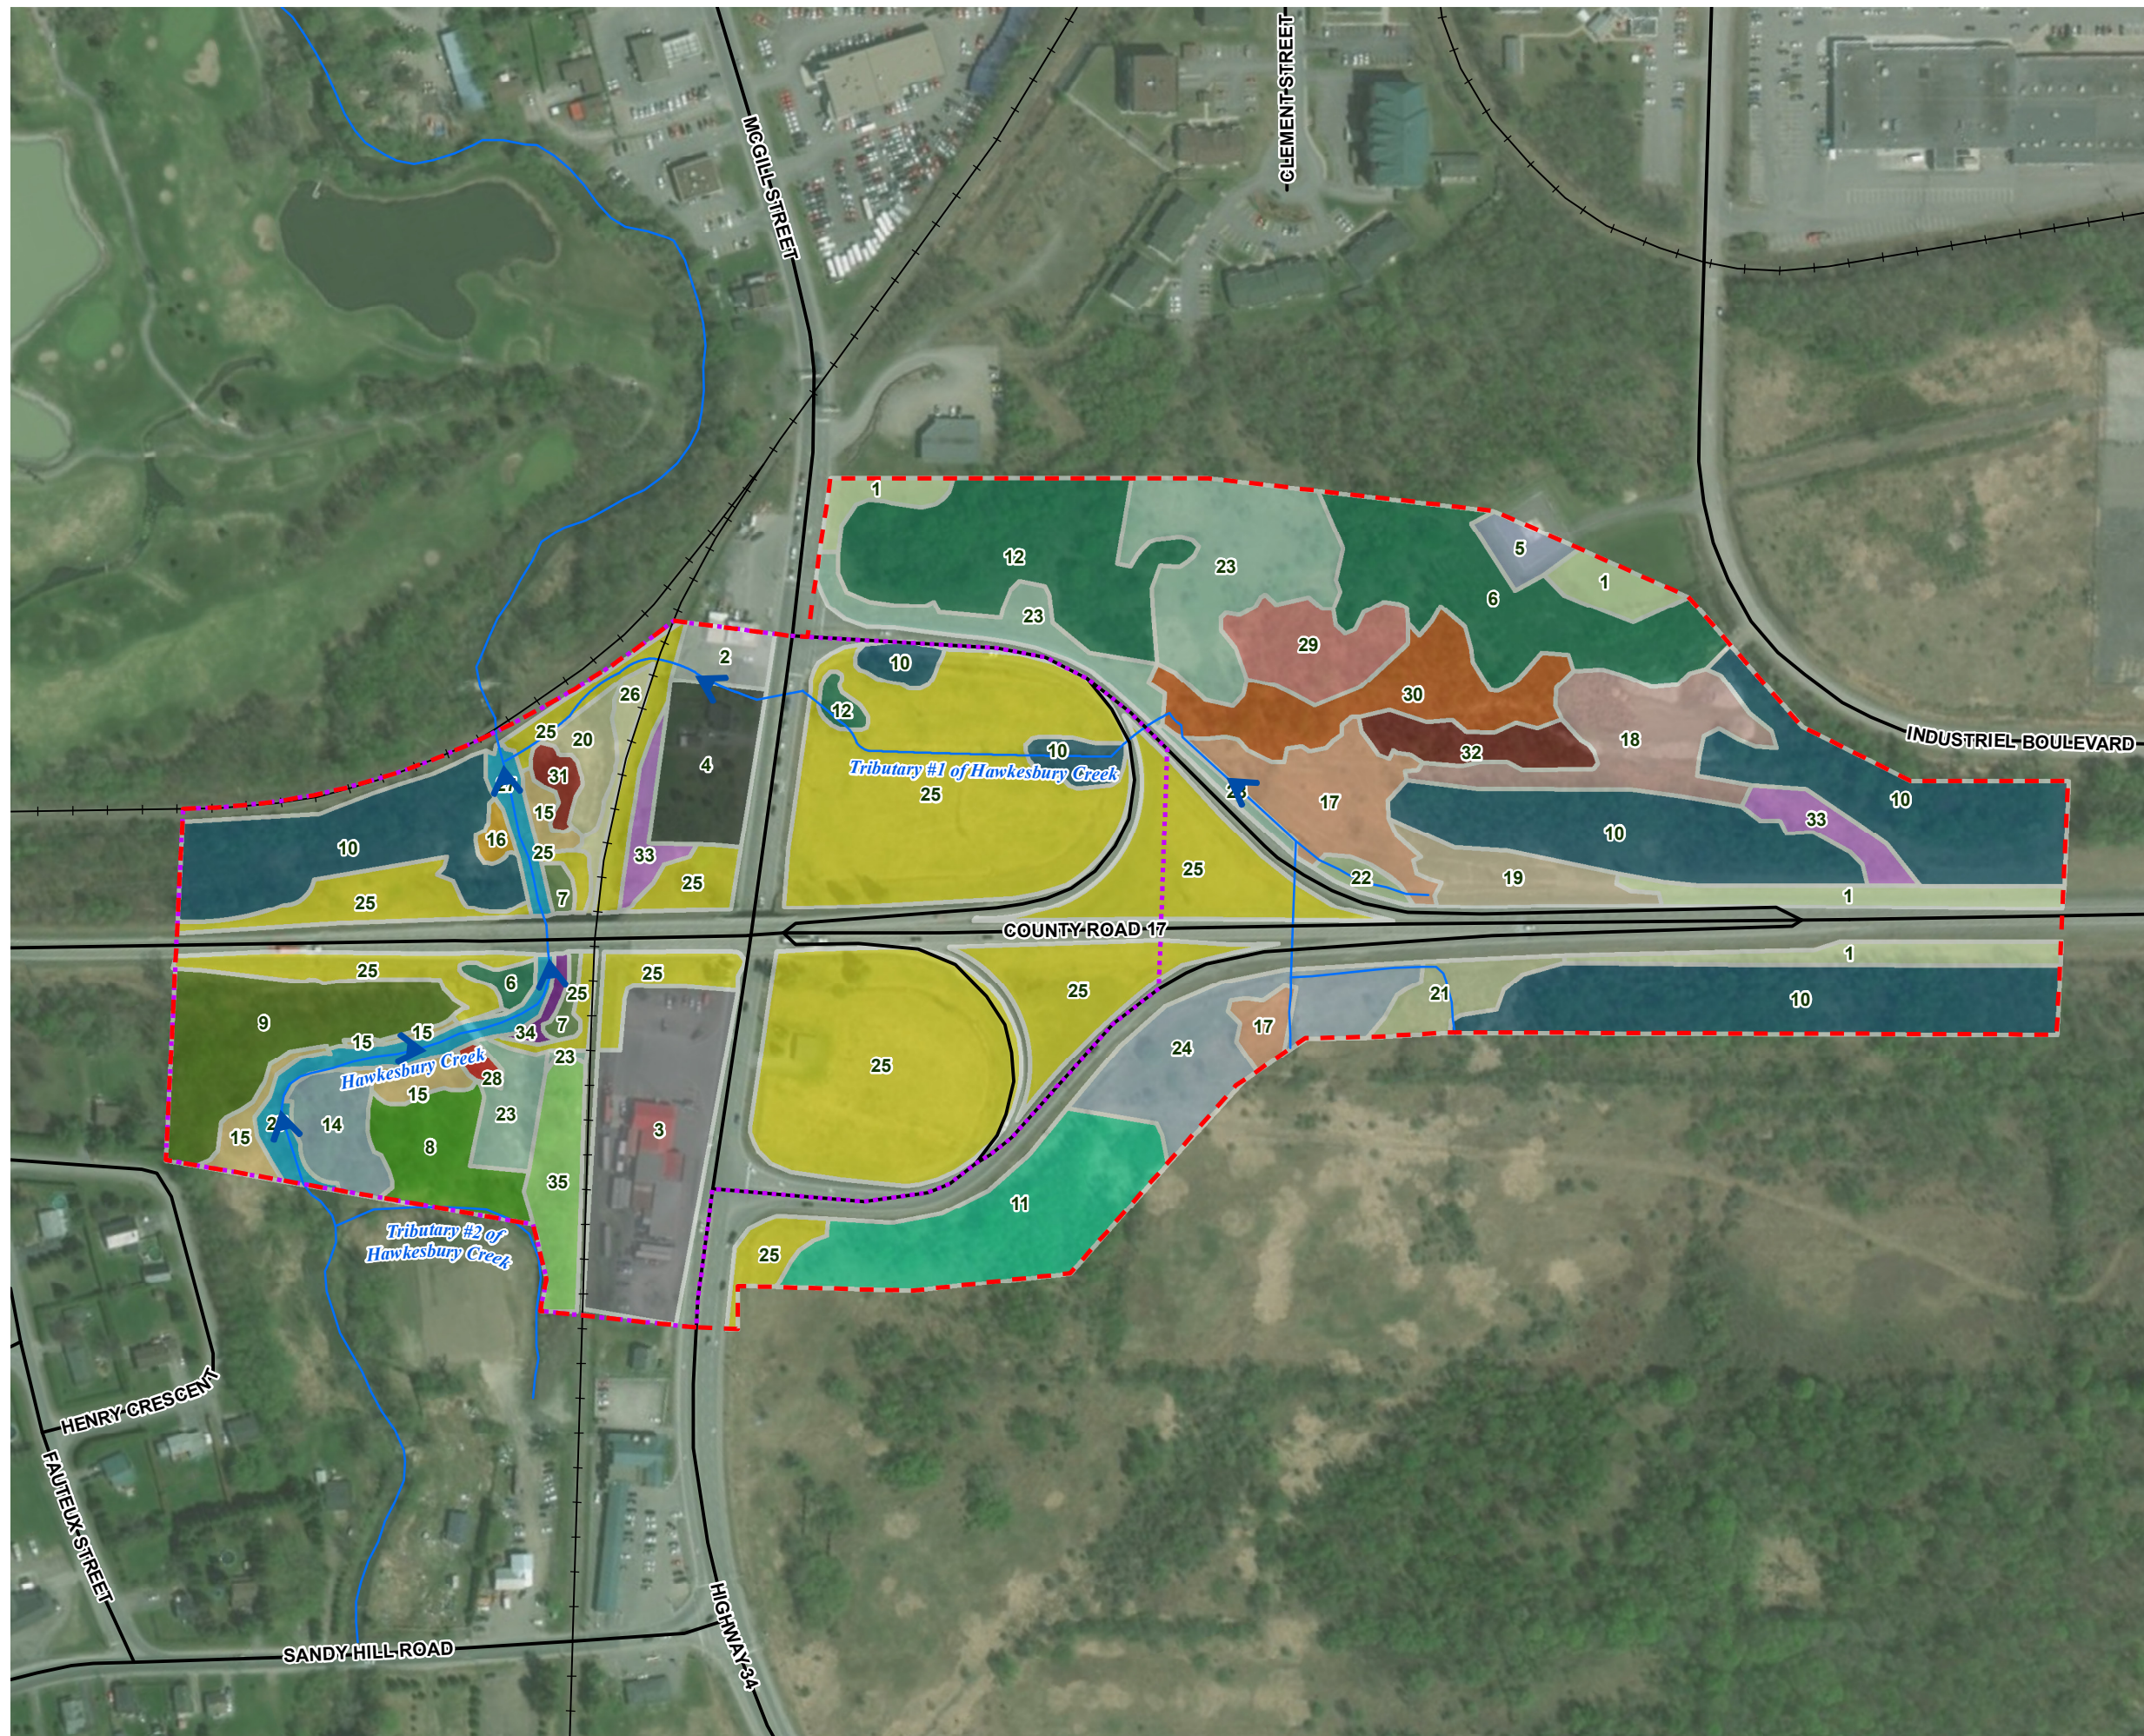
**NATURAL ENVIRONMENT SITE INVESTIGATION RESULTS**  
FIGURE 3

The descriptions of new ELC natural vegetation communities observed as part of verification of the TEIAR Study Area and the Revised Study Area are outlined in Table 1 in Attachment 3 and the boundaries and locations of these communities are shown on Figure 3 in Attachment 1. The descriptions of previously identified ELC communities that were verified as part of the June 12 field investigation are available in the 2019 TEIAR (Dillon). The general locations of Wild Parsnip are shown on Figure 5 in Attachment 1.

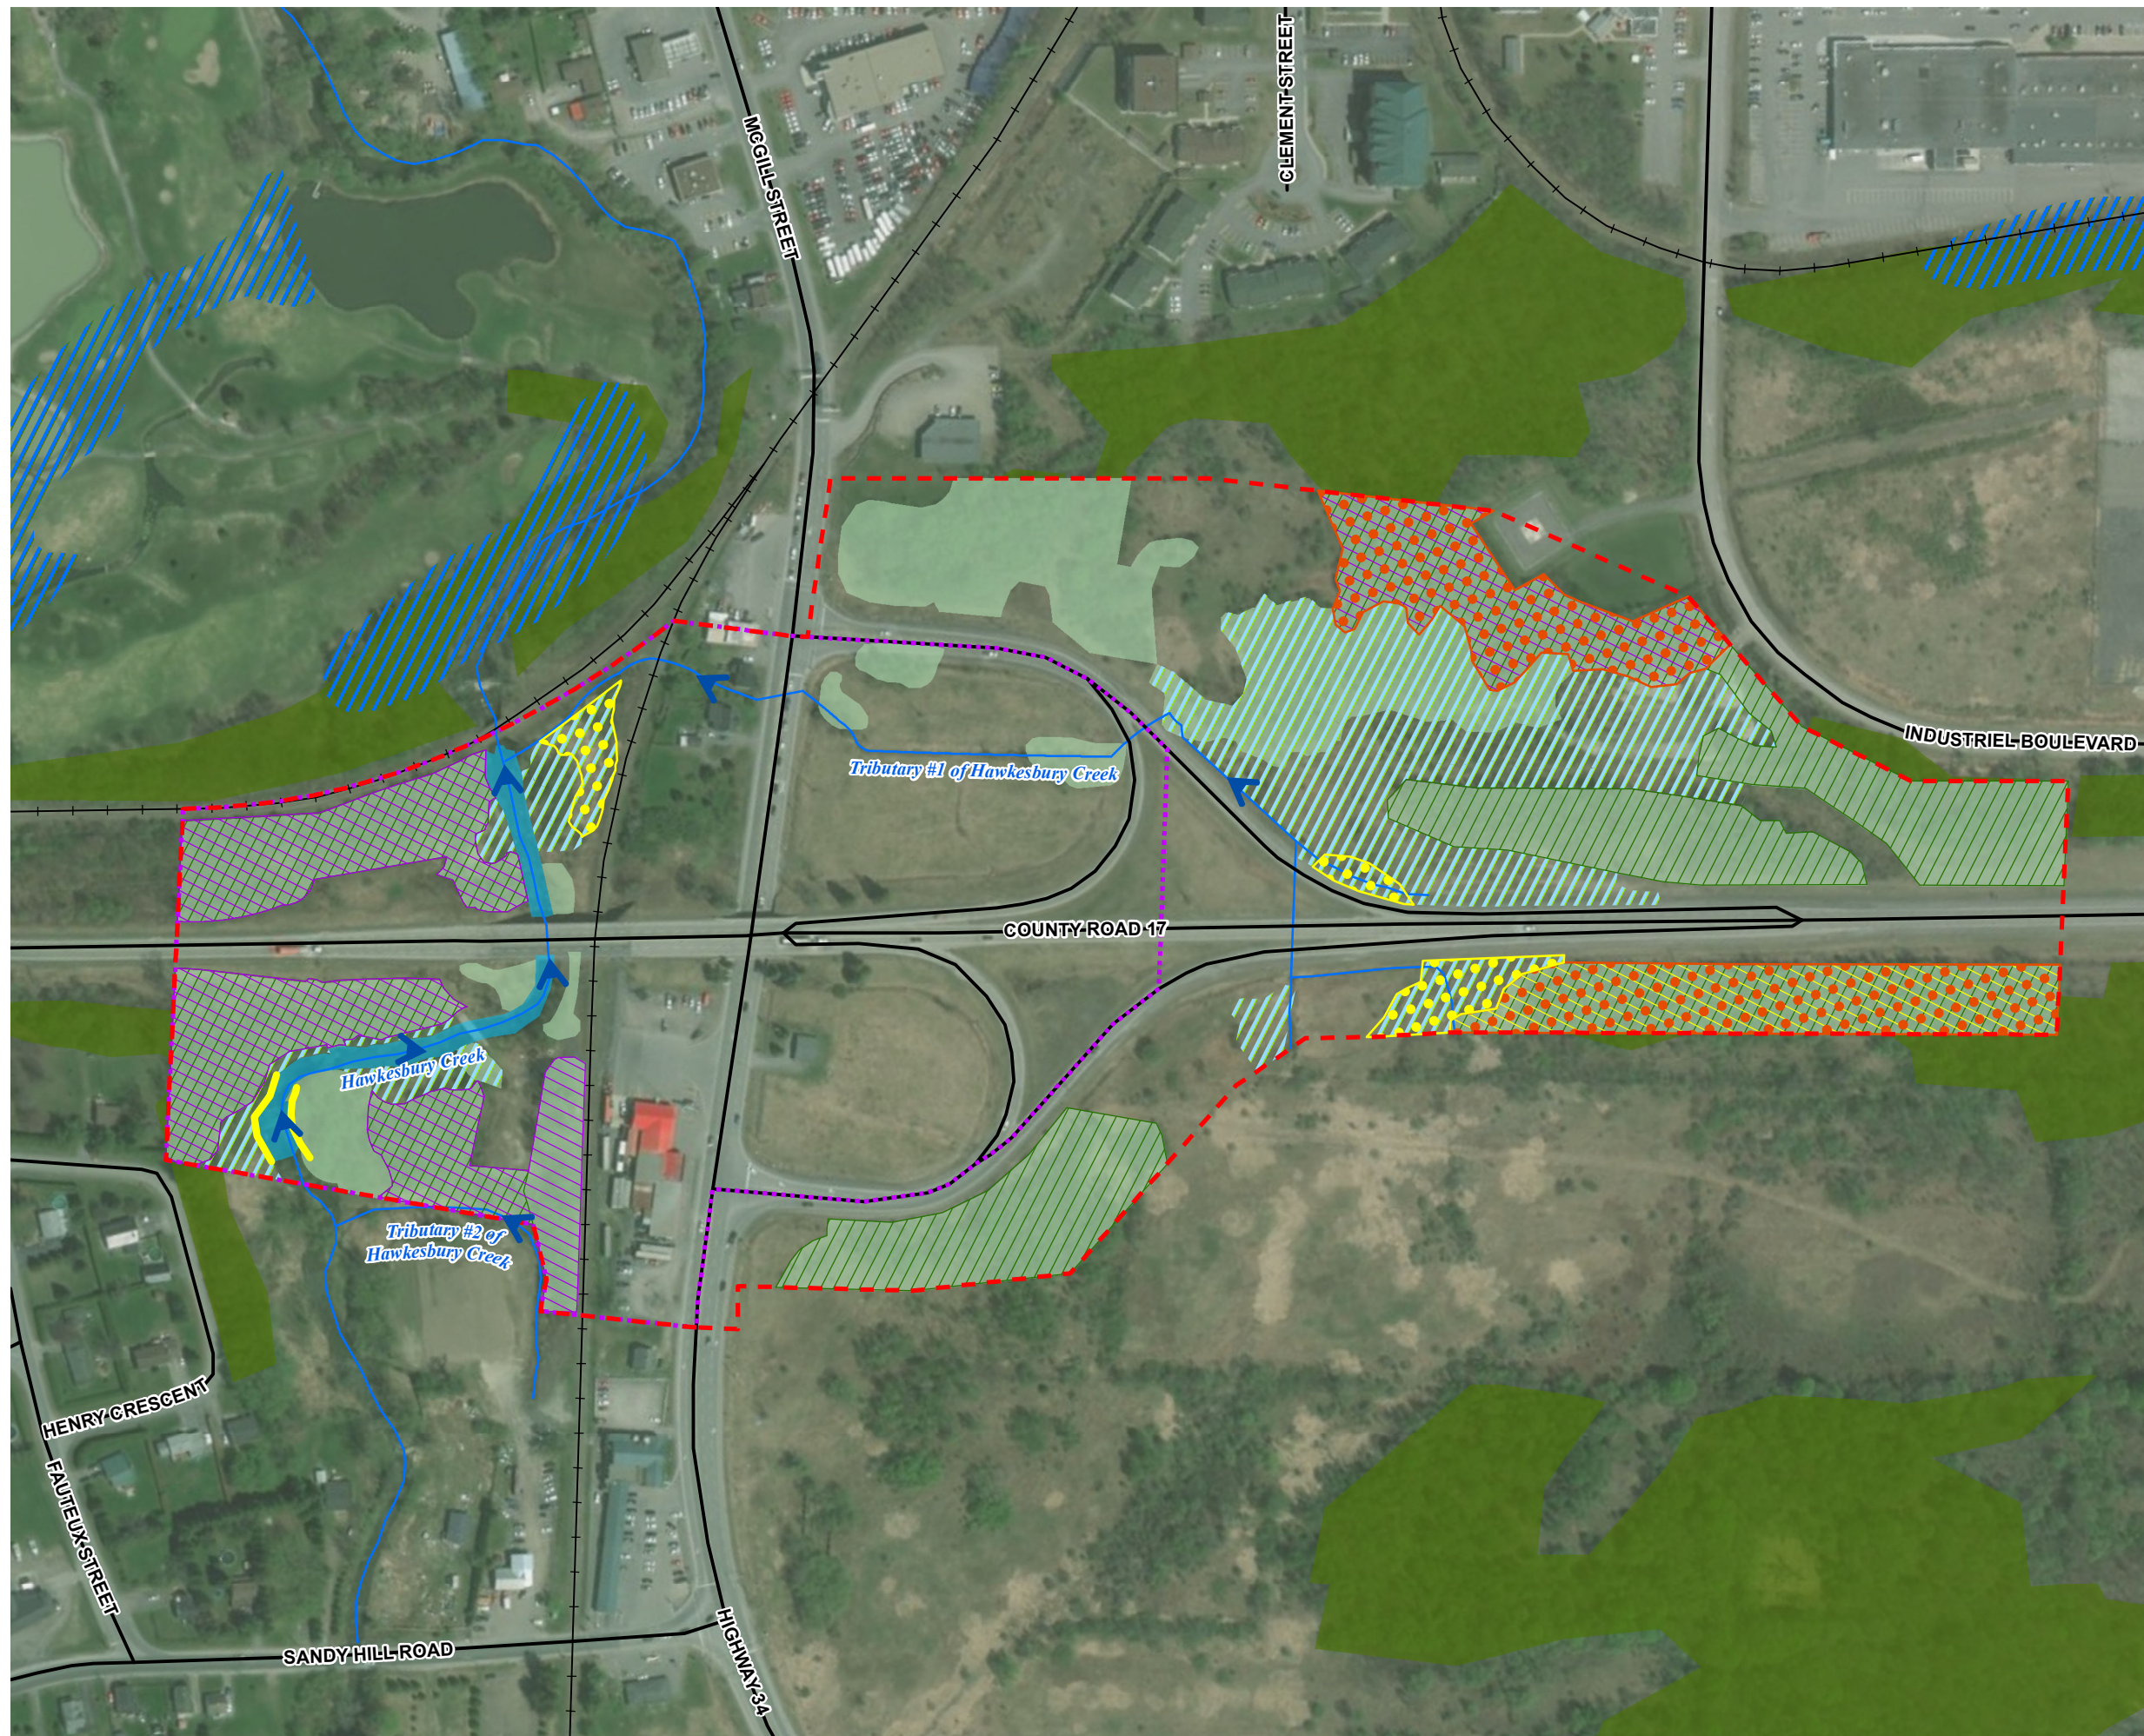
**CANDIDATE SIGNIFICANT WILDLIFE HABITAT**  
FIGURE 4

- **Seasonal Concentration Areas of Animals**
  - Bat Maternity Colonies. Bat maternity colonies may be present in the wooded areas identified within the Revised Study Area that were observed to contain suitable bat roosting trees and snags ( $\geq 25$  centimetres diameter at breast-height (DBH)). Bat Maternity Colonies occur throughout the Revised Study Area.

- **Rare Vegetation Communities or Specialized Habitat for Wildlife**
  - Amphibian Breeding Habitat. Select wetlands in the form of marshes within the Revised Study Area were observed to contain shallow water habitat ideal for amphibian breeding.

- *Turtle Nesting Areas (Snapping Turtle (Chelydra serpentina) and Northern Map Turtle (Graptemys geographica))*.  
The riparian area adjacent to Hawkesbury Creek in the Revised Study Area provides potential nesting habitat above the high water mark where vegetative cover is sparse and suitable nesting substrate was observed.

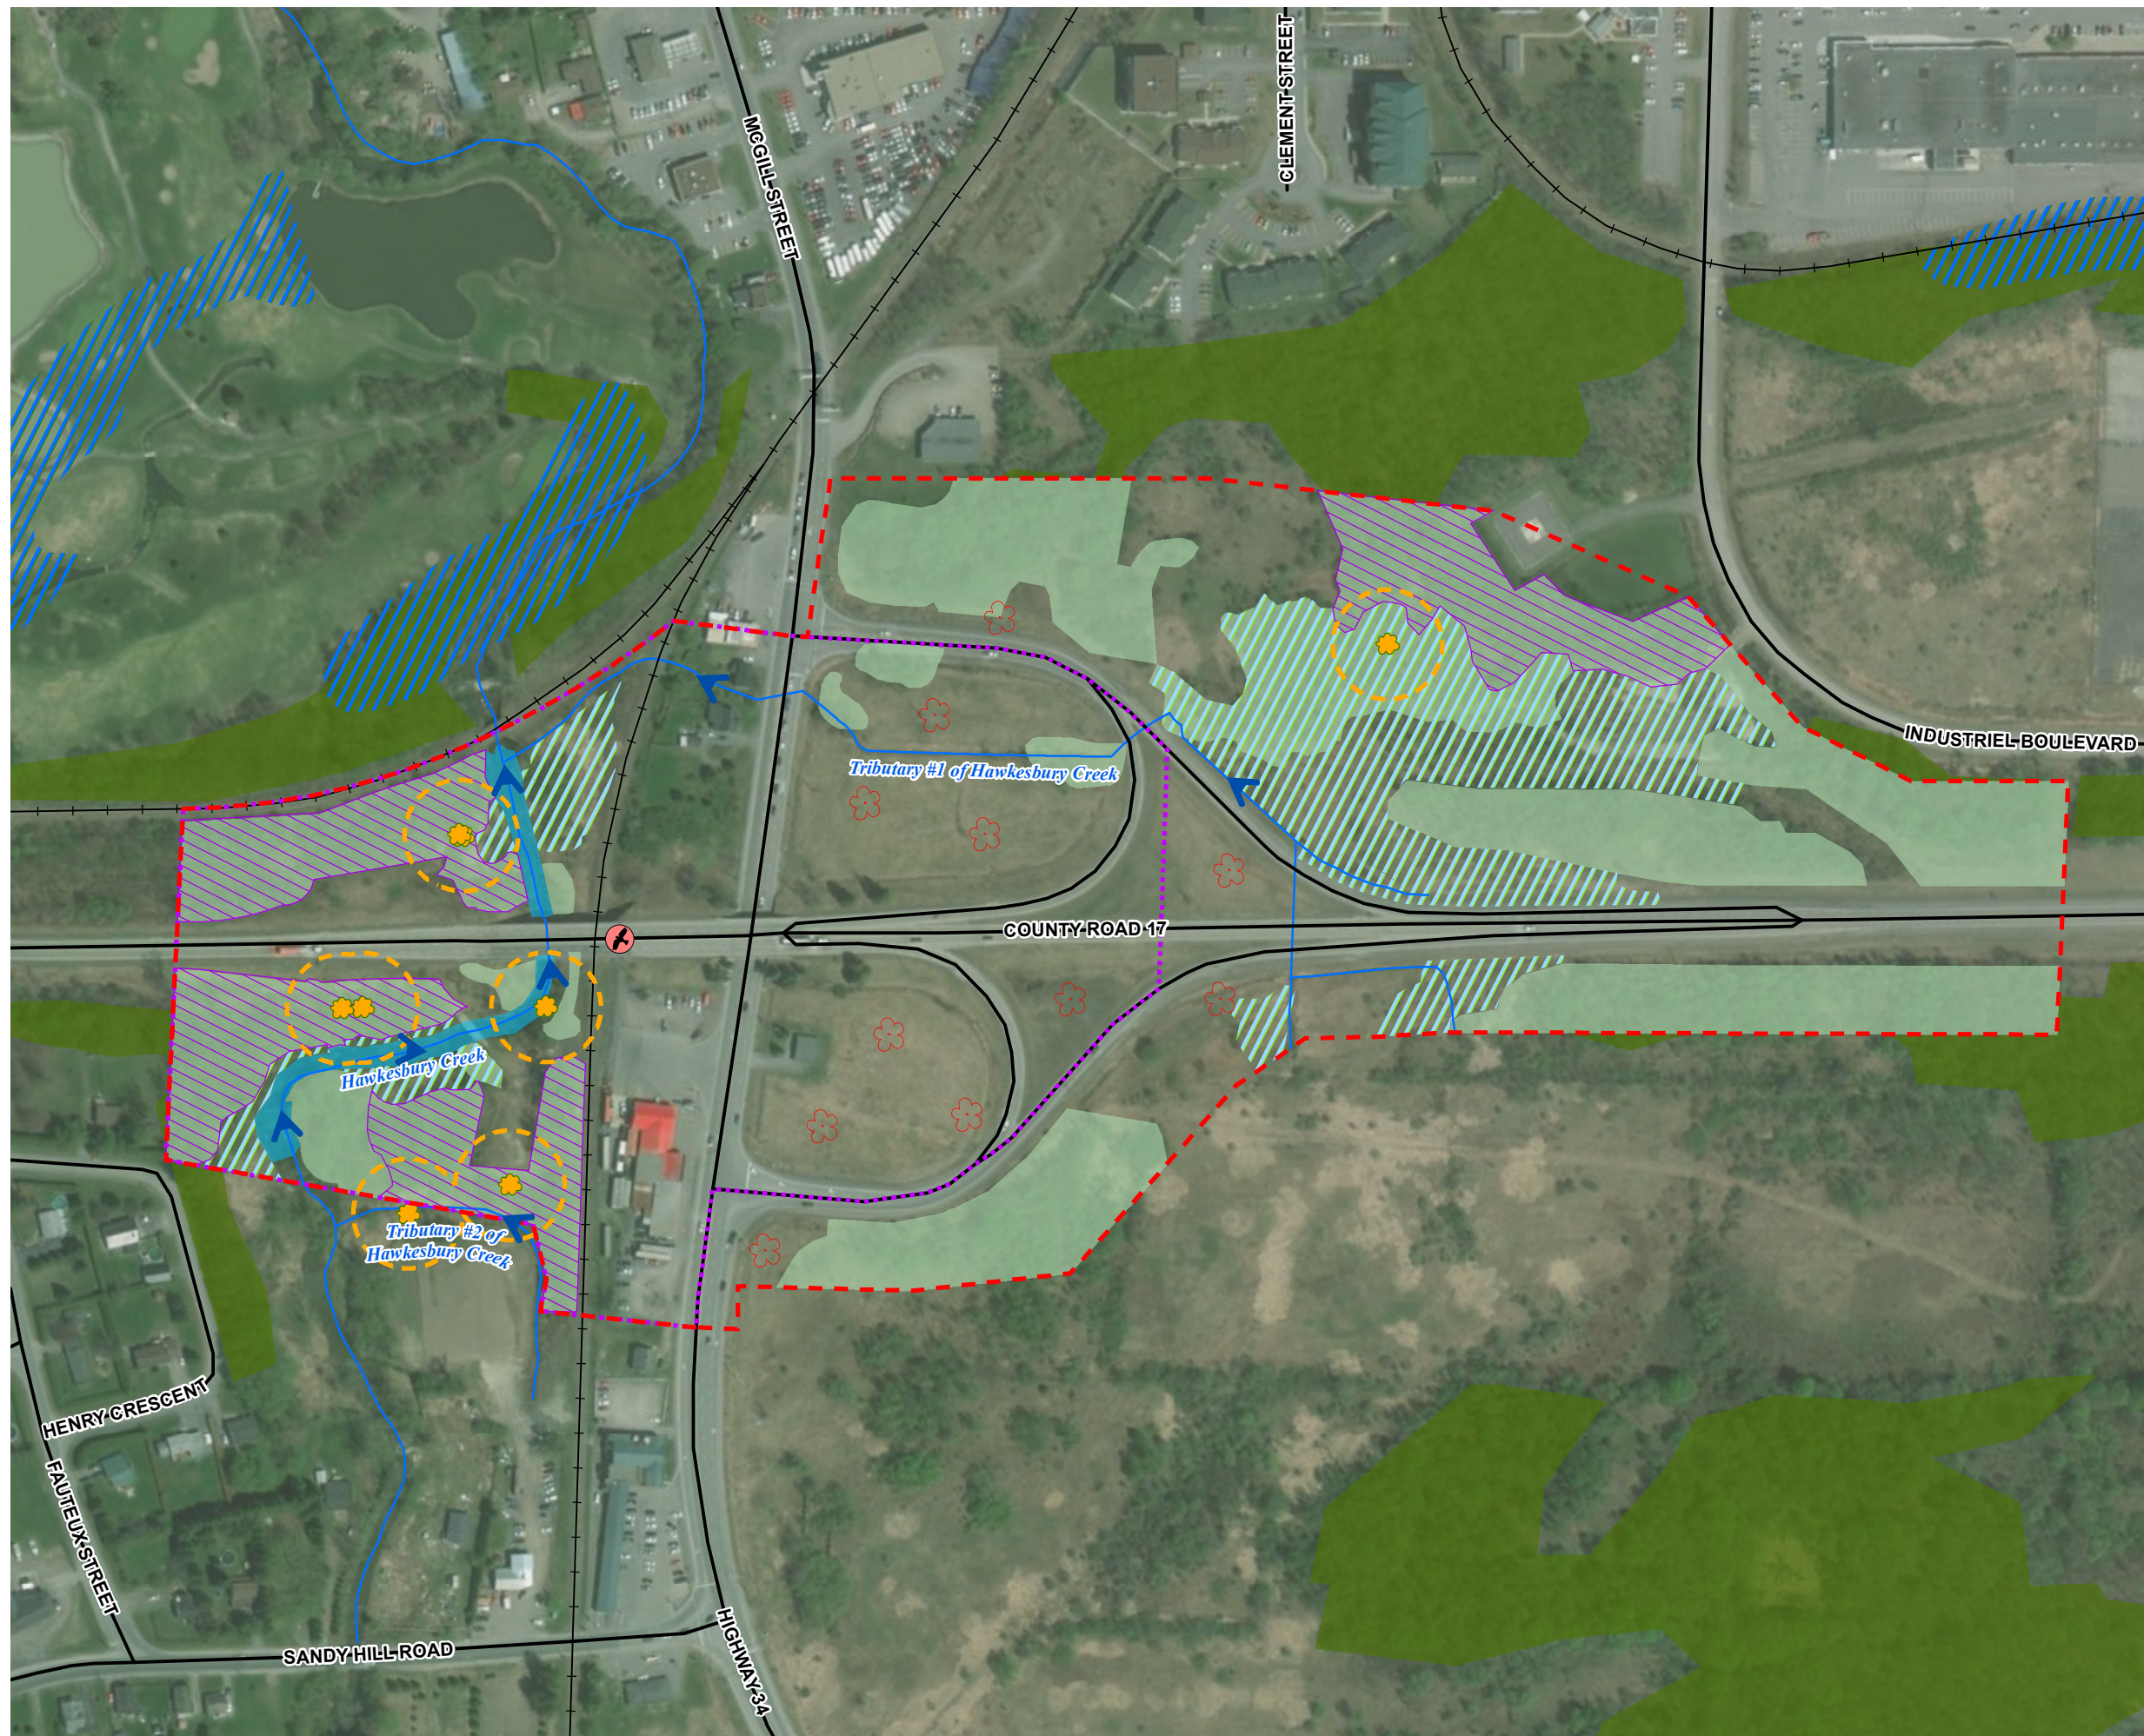
**ENVIRONMENTAL CONSTRAINTS AND SAR HABITAT**  
FIGURE 5

- **Barn Swallow**  
One Barn Swallow nest was observed along the top of the eastern abutment to the Hawkesbury Creek CNR Overhead.
- **Butternut**  
In total, seven Butternut trees were identified within the Revised Study Area, six of which were previously identified inside the TEIAR Study Area from the 2019 TEIAR (Dillon) and one occurs as a new observation. The new Butternut was observed as a sapling in excellent condition within the northeast portion of the Revised Study Area. Note: During field verification of Butternut occurrence, two Butternut trees previously observed as part of the 2019 TEIAR were not counted as part of the total as they were observed uprooted and now occur as deadfall. In addition, one new Butternut sapling in excellent condition was observed southwest and outside of the southwest border of the 2019 TEIAR Study Area nearby Hawkesbury Creek.

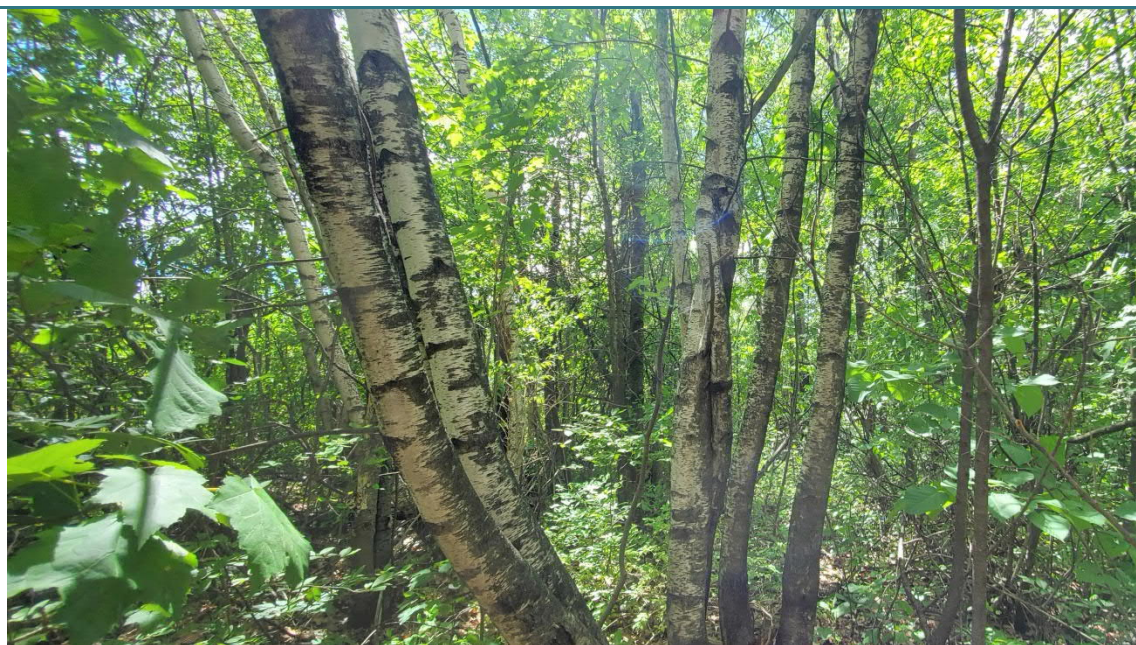
Photo #2  
June 12, 2020

FOD3-1  
Dry-Fresh Poplar Deciduous Forest

Facing west from, interior of forest  
that occurs within the TEIAR Study  
Area.

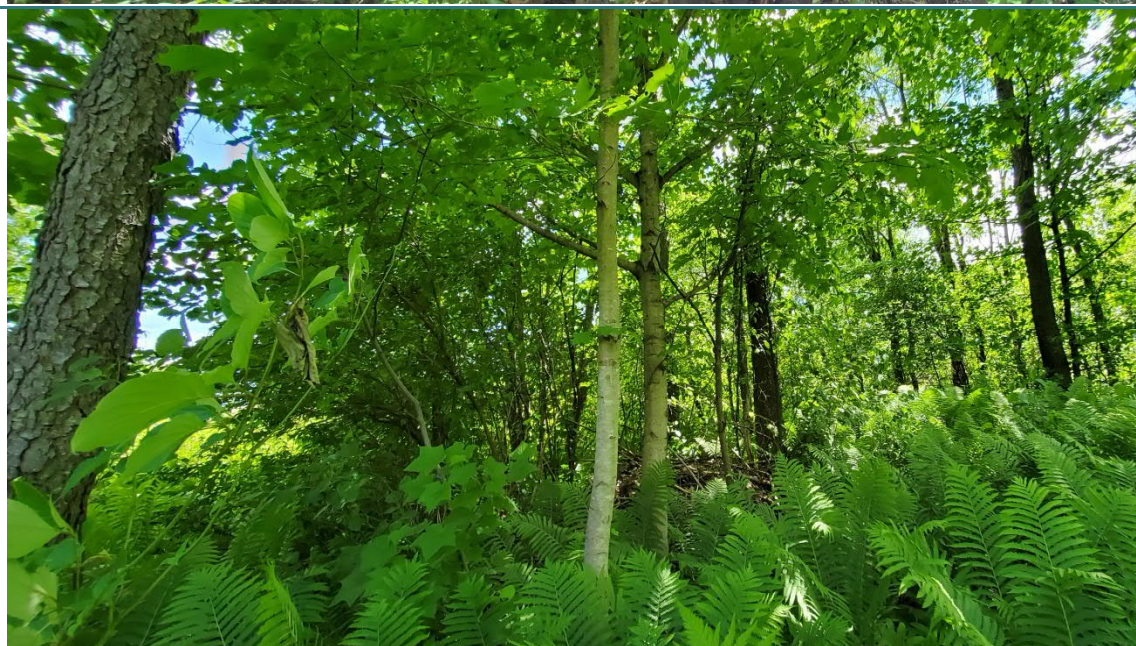
Photo #3  
June 12, 2020

FOD5-2  
Dry-Fresh Sugar Maple-Beech  
Deciduous Forest

Facing south from interior of the  
forest.

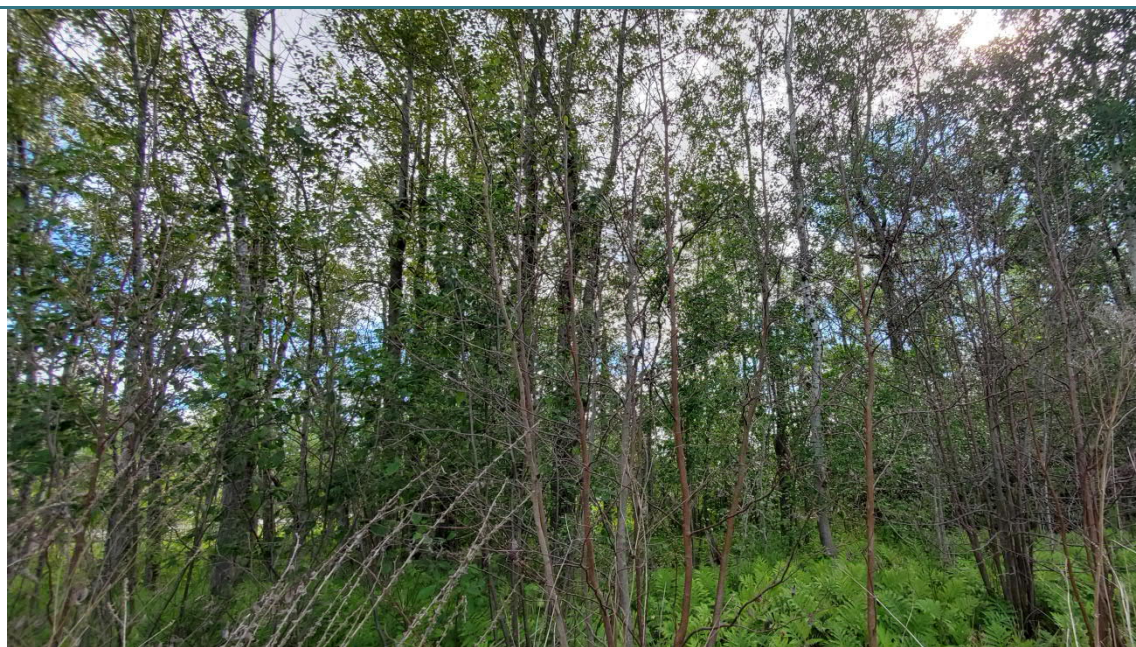
Photo #4  
June 12, 2020

FODM8-1  
Fresh-Moist Poplar Deciduous Forest

Facing south at forest from Common Reed Graminoid Mineral Meadow Marsh (MAMM1-12) within the hydro-electric corridor that occurs within the Revised Study Area.

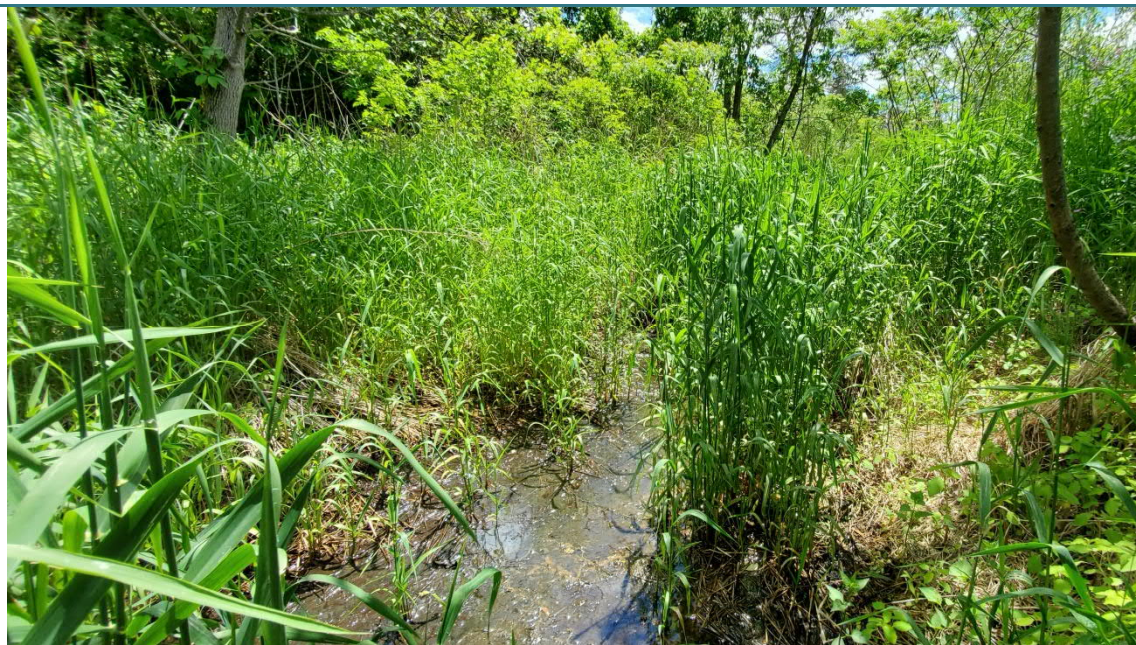
Photo #30  
June 12, 2020

Tributary #2 of Hawkesbury Creek

Facing east (upstream) of Tributary #2  
from segment that occurs within and  
along the TEIAR Study Area.

The extents of both Tributary #1 and Tributary #2 of Hawkesbury Creek are shown on Figures 3 to 5 in Attachment 1.
