**Appendix K**  
*Impact Assessment of the N/S-W  
and E-N/S Ramp Realignments*

<b>Subject</b>	<b>Impact Assessment of the N/S-W and E-N/S Ramp Realignments (Final - Rev A)</b>	<b>Project Name</b>	Hawkesbury Bridge Replacements
<b>Attention</b>	Brian Utigard (MTO)	<b>Project No.</b>	GWP 4203-15-00
<b>From</b>	Junaid Ahmed (Jacobs)		
<b>Date</b>	September 1, 2020		
<b>Copies to</b>	Frank Vanderlaan (MTO) Matthew McFadden (Jacobs) Douglas Raby (Jacobs) Vlad Manalastas (Jacobs) Tanya Cross (Dillon) Brendan Peterson (Dillon) Adele Mochrie (Dillon) Catherine Rebry (Dillon)

TO: Brian Utigard, P.Eng, Ministry of Transportation, Ontario (MTO)  
FROM: Connor Edington, Dillon Consulting Limited (Dillon)  
cc: John Hanna, MTO  
Frank Vanderlaan, MTO  
Matthew McFadden, Jacobs  
Adele Mochrie, B.Sc., Dillon  
Dayna LeClair, Dillon  
Tanya Cross, P.Eng., Dillon  
Brendan Peterson, Dillon  
DATE: July 14, 2020  
SUBJECT: County Road 17 Bridge Replacements (GWP 4023-15-00)  
Natural Heritage Existing Conditions Update Memo  
OUR FILE: 17-5180

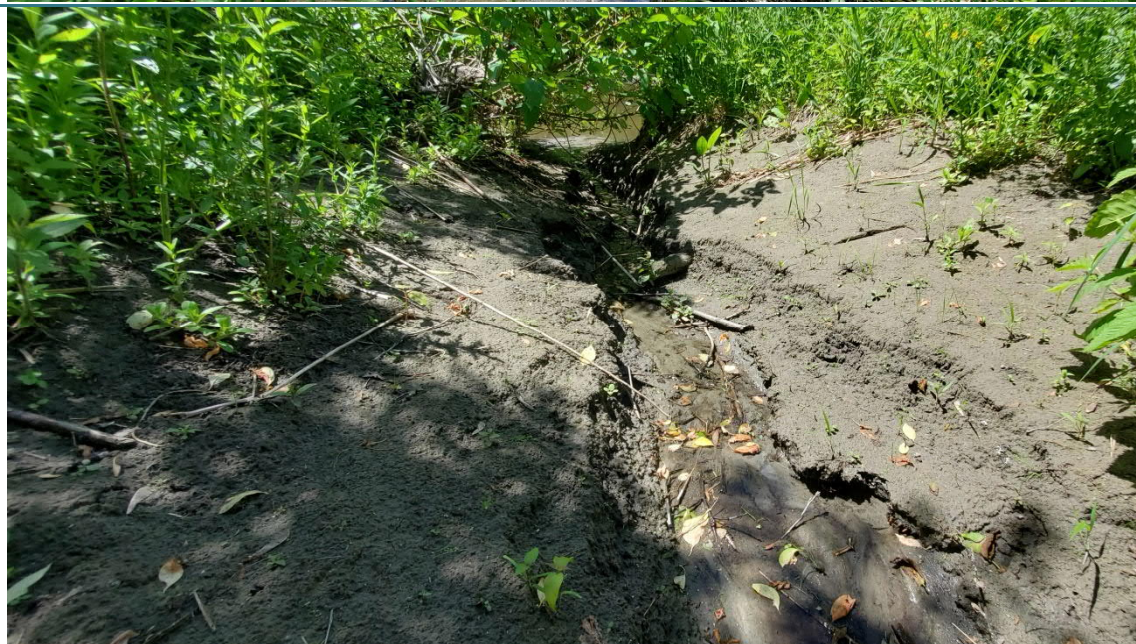
Photo #31  
June 12, 2020

Tributary #2 of Hawkesbury Creek

Facing west (downstream) at outlet of  
Tributary #2 where it discharges into  
Hawkesbury Creek.

The extents of both Tributary #1 and Tributary #2 of Hawkesbury Creek are shown on Figures 3 to 5 in Attachment 1.

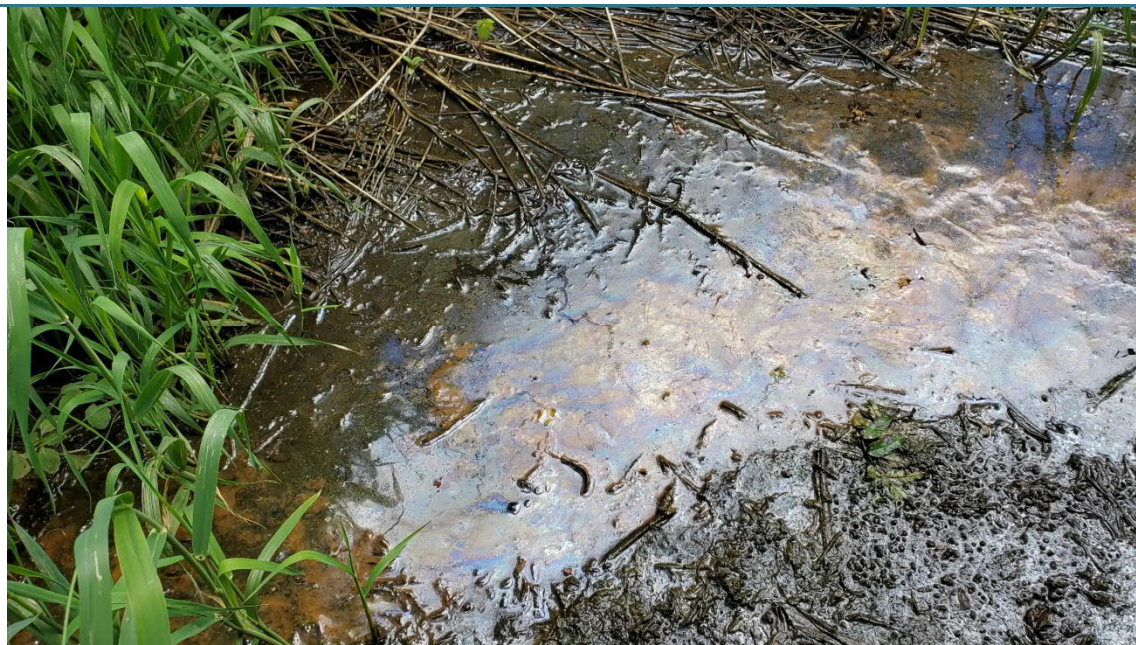
Photo #32  
June 12, 2020

Facing east (upstream) at iron-oxidizing bacteria film on surface water of Tributary #2.

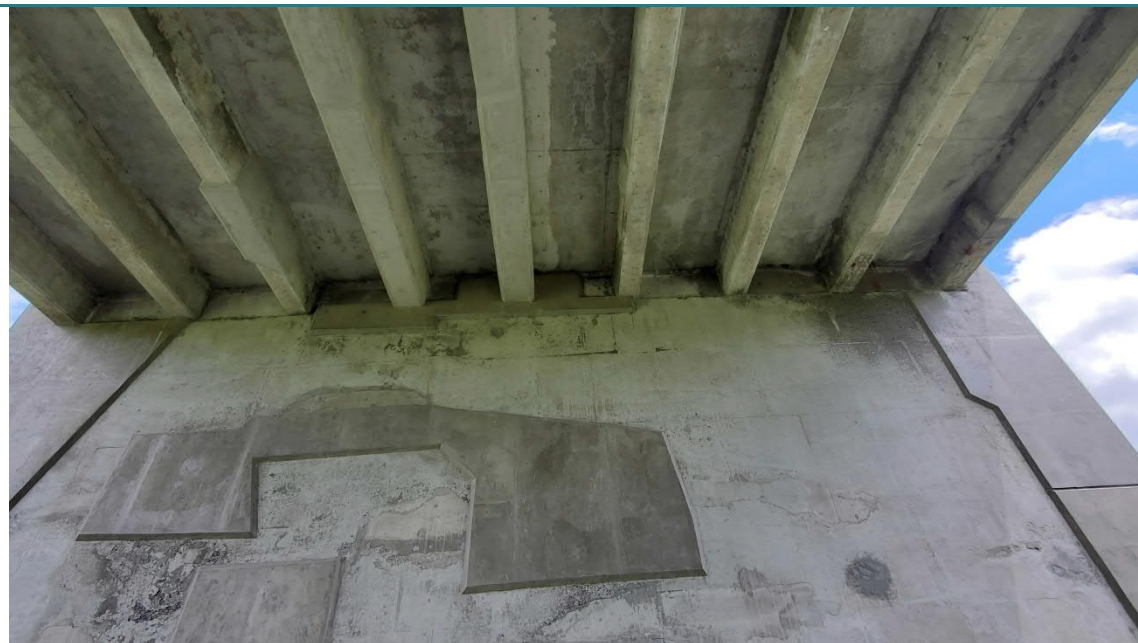
Photo #34  
June 12, 2020

Facing east at eastern abutment of the CNR overhead.

- **Barn Swallow**  
One Barn Swallow nest was observed along the top of the eastern abutment to the Hawkesbury Creek CNR Overhead.
- **Butternut**  
In total, seven Butternut trees were identified within the Revised Study Area, six of which were previously identified inside the TEIAR Study Area from the 2019 TEIAR (Dillon) and one occurs as a new observation. The new Butternut was observed as a sapling in excellent condition within the northeast portion of the Revised Study Area. Note: During field verification of Butternut occurrence, two Butternut trees previously observed as part of the 2019 TEIAR were not counted as part of the total as they were observed uprooted and now occur as deadfall. In addition, one new Butternut sapling in excellent condition was observed southwest and outside of the southwest border of the 2019 TEIAR Study Area nearby Hawkesbury Creek.

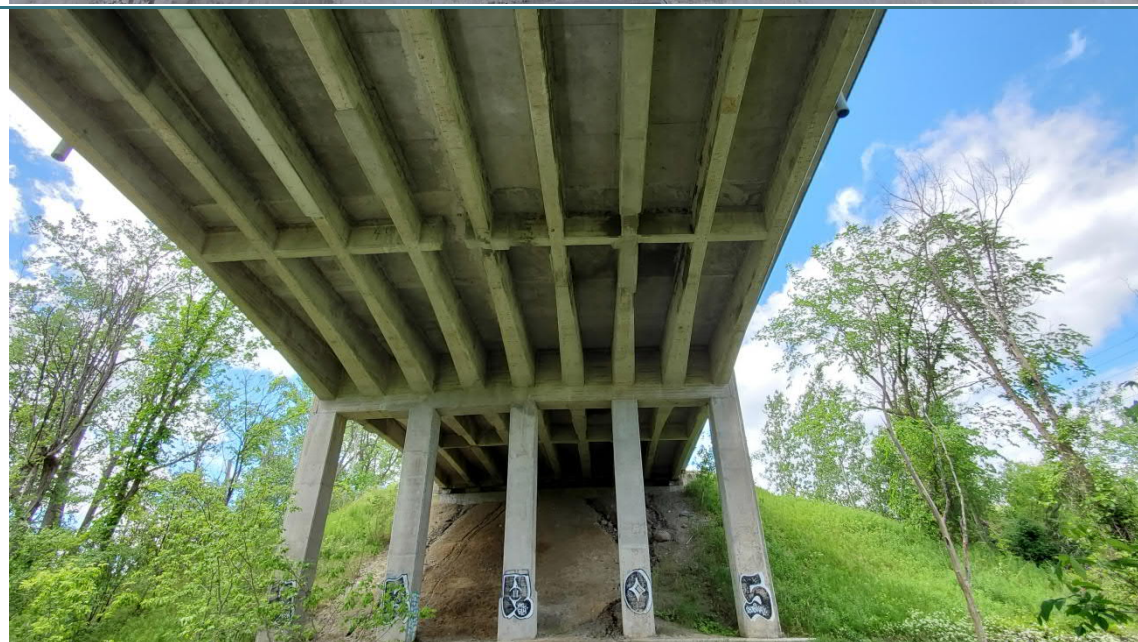
Hawkesbury Creek/CNR Overhead

Facing west at west abutment of the CNR overhead from east shore of Hawkesbury Creek.

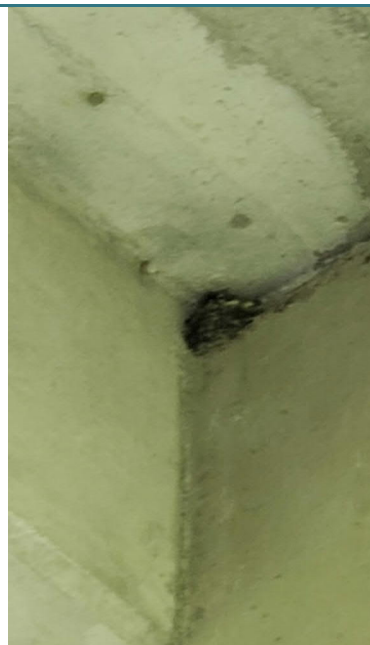
Photo #36  
June 12, 2020

Hawkesbury Creek/CNR Overhead

Facing east at Barn Swallow nest  
constructed against the east  
abutment to CNR Overhead

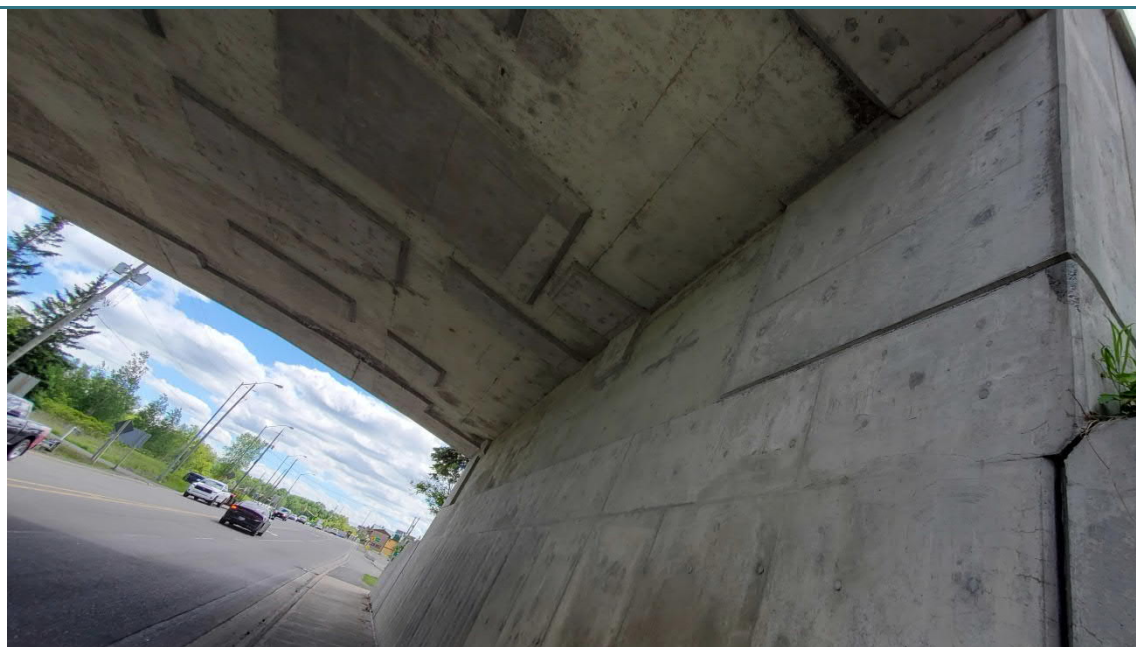
Facing west at Highway 34 Underpass from the shoulder of the southbound lane.

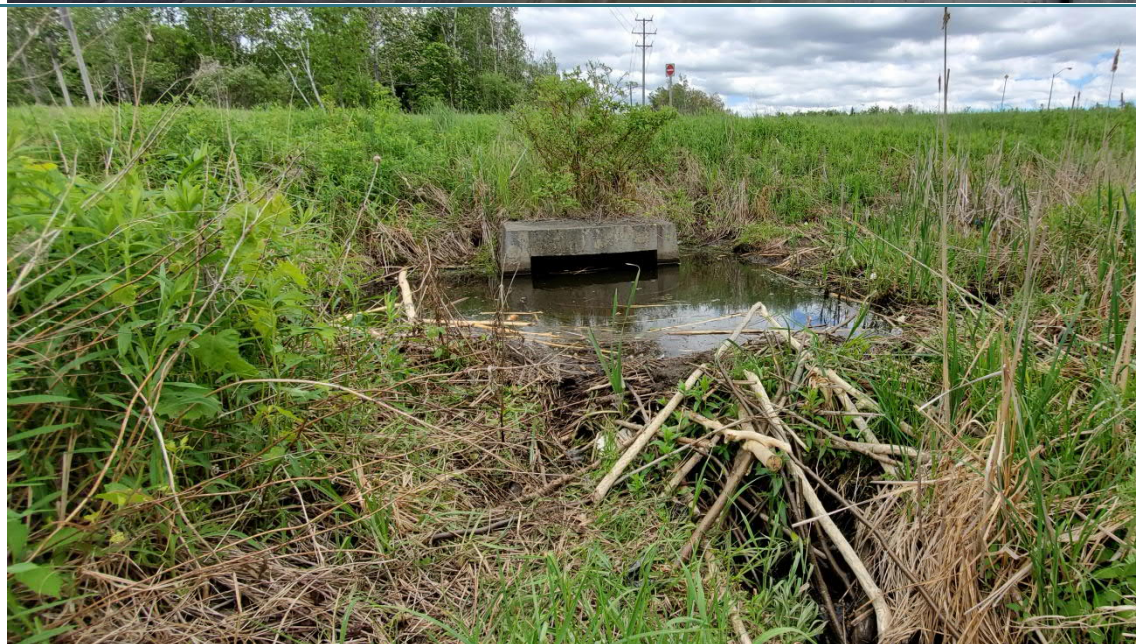
Photo #39  
June 12, 2020

Facing northeast at active Beaver dam located within Tributary #1 of Hawkesbury Creek at outlet of culvert that crosses the westbound off ramp of County Road 17.

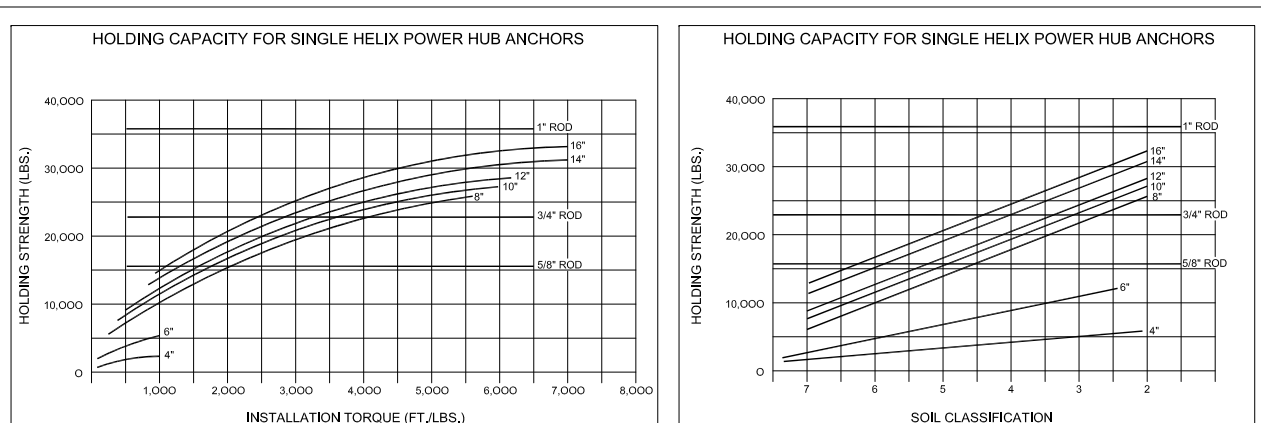
**HOLDING CAPACITY DETAIL - REFER TO NOTE 7 (AERIAL) FOR ANCHOR SPECIFICATIONS**  
SCALE: N.T.S.

STRAND DIAMETER	DESCRIPTION	STRAND TENSION AT INSTALLATION TEMPERATURE											
		0°F -17.8°C	10.0°F -12.2°C	20.0°F -6.7°C	30.0°F -1.1°C	40.0°F 4.4°C	50.0°F 10.0°C	60.0°F 15.6°C	70.0°F 21.1°C	80.0°F 26.7°C	90.0°F 32.2°C	100.0°F 37.8°C	
1/4"	180 GRADE, 7 WIRE GALV. BREAKING STRENGTH = 6,650lbs.	1550lbf 6895N	1474lbf 6558N	1440lbf 6227N	1324lbf 5890N	1250lbf 5560N	1175lbf 5227N	1100lbf 4893N	1001lbf 4452N	900lbf 4003N	863lbf 3838N	825lbf 3670N	
5/16"	180 GRADE, 7 WIRE GALV. BREAKING STRENGTH = 11,200lbs.	1905lbf 8474N	1820lbf 8096N	1736lbf 7722N	1651lbf 7344N	1568lbf 6975N	1484lbf 6601N	1400lbf 6228N	1318lbf 5863N	1237lbf 5502N	1156lbf 5142N	1076lbf 4786N	
3/8"	180 GRADE, 7 WIRE GALV. BREAKING STRENGTH = 15,400lbs.	2675lbf 11899N	2562lbf 11396N	2449lbf 10894N	2337lbf 10395N	2224lbf 9893N	2112lbf 9395N	2000lbf 8896N	1890lbf 8407N	1780lbf 7918N	1671lbf 7433N	1563lbf 6953N
